December 10, 2025

## Re: Sunset Lake – Ashburnham/Winchendon, MA – 2025 Year End Report

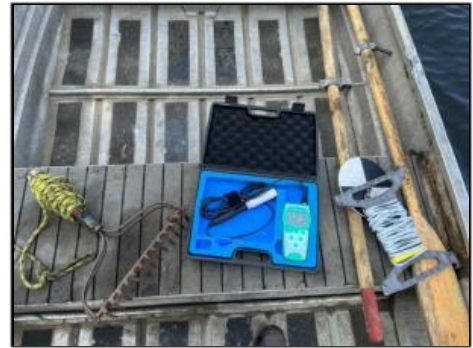
throw-rake and handheld GPS/ArcGIS Field Maps, as applicable. Additionally, dissolved oxygen (DO) and temperature readings were collected throughout the season using a calibrated YSI meter with optical sensor (meters and equipment pictured in Figure 3 below). Dissolved oxygen is the amount of oxygen in water that is available to aquatic organisms. DO is necessary to support fish spawning, growth, and activity. Tolerance varies by species, please see the figure provided for a general range of fish tolerance (Source: [epa.gov](http://epa.gov)). Dissolved oxygen can be affected by many outside factors, such as temperature, time of day, and

Figure 3: Meters and equipment utilized during each site visit

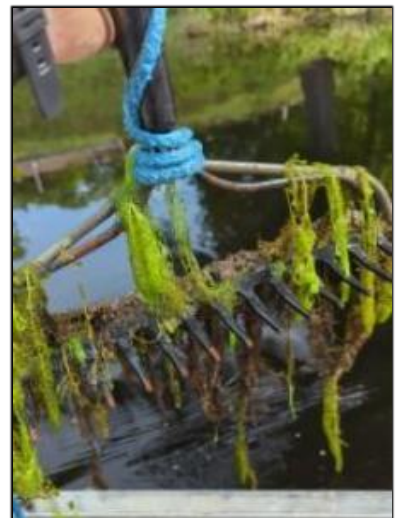
Figure 4: Low-water milfoil observed during May visit

small patches of filamentous algae and ribbon-leaf pondweed. The northwestern-most cove boasted moderately dense stands of both low-water milfoil and bladderwort, becoming increasingly scarce moving southward. The majority of the western/southwestern shoreline was absent of any nuisance aquatic vegetation. The southernmost cove contained moderate to scarce densities of bladderwort and low-water milfoil as previously surveyed, with a few small populations of ribbon-leaf being observed. The highest densities of bladderwort were concentrated on the southern cove's eastern side. One small algal mat was observed in this cove, along with a few nitella fragments. Snailseed densities were sparse to moderate and were found primarily throughout all of the lake's coves. The easternmost cove contained scarce to moderate patches of bladderwort and low-water milfoil, with a few stands of cattails lining the shorelines. The northeastern coves contained scarce, scattered pockets of ribbon-leaf pondweed, bladderwort, cattails, and low-water milfoil. Pollen was present on windblown shorelines.

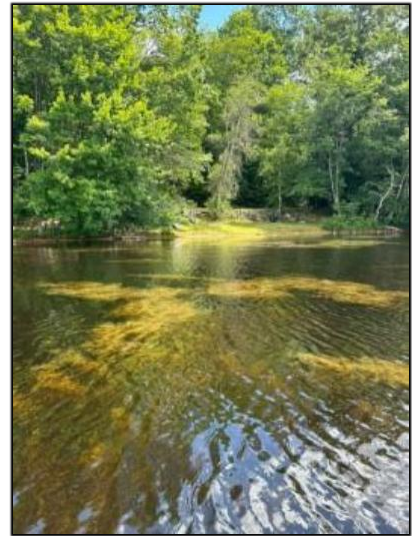
Figure 5: Thin-leaf pondweed observed during June visit

The site visit consisted of completing a brief survey, collecting basic water quality data, and performing an herbicide treatment. The survey was done to confirm species/distribution, potential treatment areas, and confirm treatment timing. A map of potential treatment acreage was sent to the Association prior to the treatment in order to confirm acreage and locations. The southeast cove contained the largest treatment area; as species within this area were found in moderate to dense levels, occupying waterfront properties and docks. The other treatment areas were primarily contained within the coves along the western, northern, and eastern shorelines, where bladderwort and snailseed pondweed, along with thin-leaf pondweed and ribbon-leaf pondweed were in abundance. The extra three acres permitted/approved by the Association were used towards any other areas where growth was observed at nuisance levels and treatment was deemed necessary. This included the northeastern cove off Spruce Drive, where low water milfoil was observed. Great coverage was achieved throughout the target areas.

As planned, a treatment was conducted for the control of target nuisance/invasive plant growth. The liquid contact Herbicide(s) was applied using a treatment boat equipped with a calibrated sub-surface injection system. This application methodology allows for even coverage within the treatment areas. The treatment was completed without issue. We anticipated plant die-off within just a few days to a few weeks. Prior to the treatment, the shoreline was posted by the Association with neon signage noting the treatment, affiliated water use restrictions, and Water & Wetland contact information. The signs fulfill permit obligations for shoreline posting.

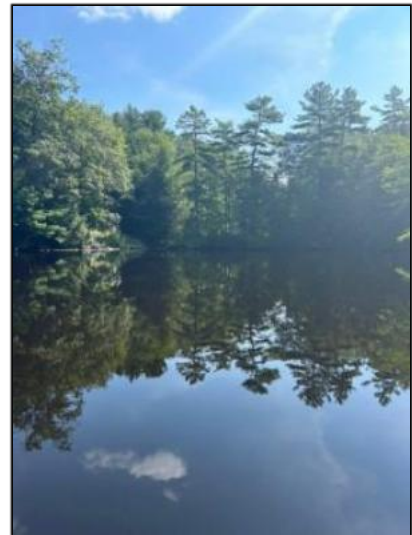
Figure 6: Improved conditions since the previous application

The purpose of this visit to Sunset Lake was to complete a post treatment survey to determine the effectiveness of the previous treatment and to help guide recommendations for the 2026 season. Minimal plant growth was documented during the survey compared to the first visit of the season. There were a couple of coves within the northern end of the lake, specifically the northeastern cove off Spruce Drive, that contained visible thin-leaf pondweed, but all populations noted were covered in epiphytic algae (which indicates that the plant is dead/decaying). Other plants, including bladderwort, low-water milfoil, and snailseed pondweed, were either not observed at this visit, were only seen as dead floating fragments, or were observed dead along the floor of the water column. This leads to the conclusion that the herbicide treatment conducted was extremely successful in the removal of all existing pondweeds, specifically within the treatment areas. Conditions had significantly improved since the previous site visit. The water clarity was slightly low due to a brown coloration, but dissolved oxygen levels were moderate during our visit.

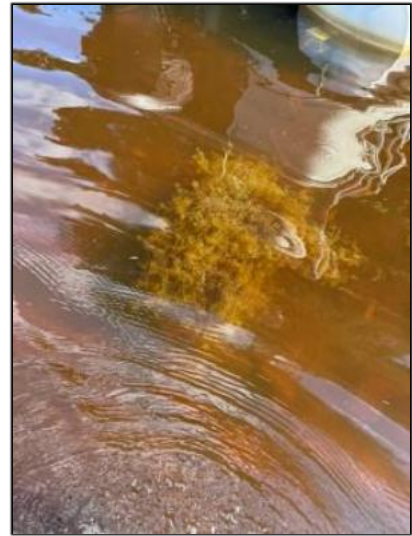
Figure 7: Bladderwort observed during September visit

This site visit consisted of a final survey for the end of the 2025 season, with the purpose of assessing the entire littoral zone and documenting the aquatic vegetation assemblage. Very little active plant growth was observed during the visit, as most species were in stages of death or decay. Native species including bladderwort, snailseed pondweed, thin-leaf pondweed, and low-water milfoil were present in scattered, low densities within previously documented areas. Aquatic vegetation overall was greatly reduced due to the herbicide treatments conducted earlier in the year. In the southern cove, where bladderwort densities had been high during early summer, almost no bladderwort remained. The few plants that persisted were brown in color and broke apart when disturbed, indicating advanced decay. Overall, the lake was in excellent condition, with no invasive aquatic species observed, healthy dissolved oxygen readings, and normal water clarity.

For 2026, we recommend continuing the same survey-based approach that emphasizes monitoring and only treating as necessary. Regular vegetation surveys should continue to guide management actions, ensuring that treatments are limited to areas where nuisance densities develop. If plant growth reaches nuisance levels, a targeted diquat application should be planned to maintain open-water conditions while preserving beneficial native vegetation. Algae should continue to be monitored closely, with copper-based algaecides implemented only if warranted by survey data. Maintaining close communication between Water & Wetland and the Far Hills Association will allow management decisions to remain adaptive and cost-effective while supporting long-term ecological balance in the lake.
